SID Panel Repair by Leon Murphy

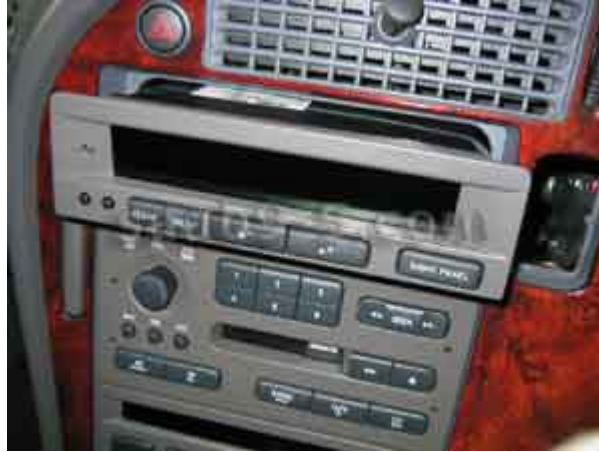
Remove SID Unit, I found by removing the 2 switch blanks next to SID I could push panel out from behind

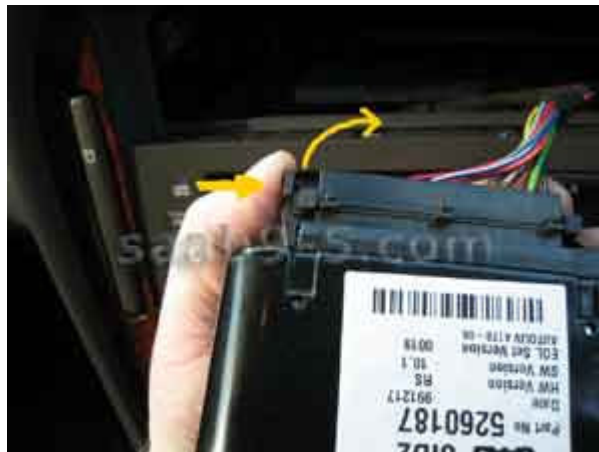
Press in plug retention clip as shown, and lift plug at a right angle

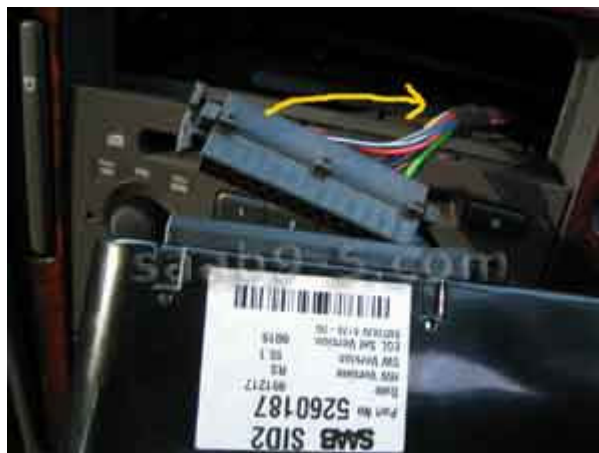
Pull cable plug to 90 degrees and remove

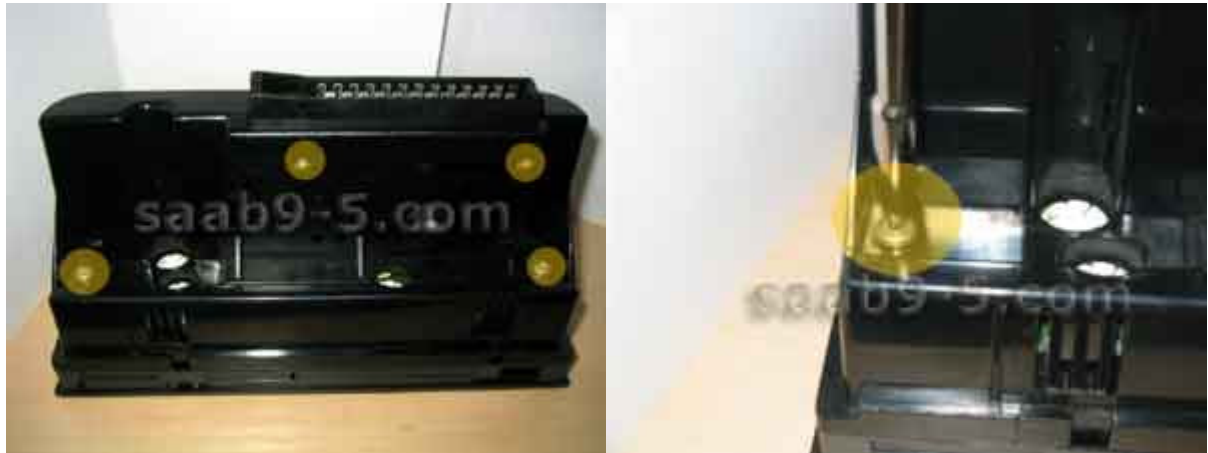
There are 4 Torx8 screws to be removed to gain access to the SID internals

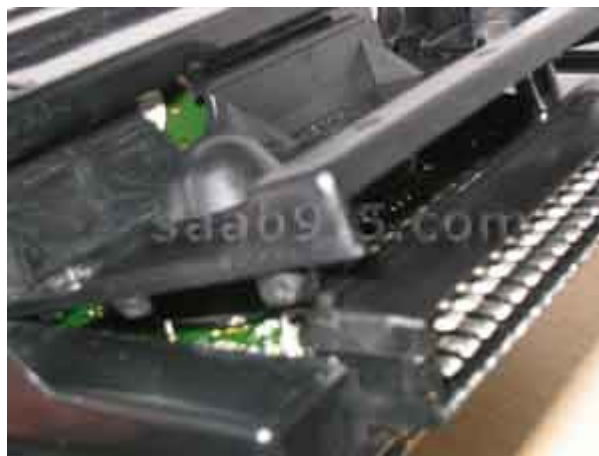
Once you have removed the 4 screws, carefully pull up the connector housing cover

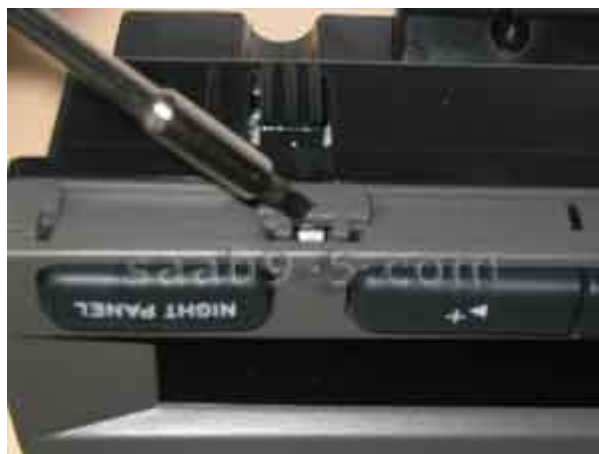
There are now 4 press tabs to be released around the units fascia, carefully push these down using a small flat blade screwdriver, at the same time applying pressure to remove the units back housing

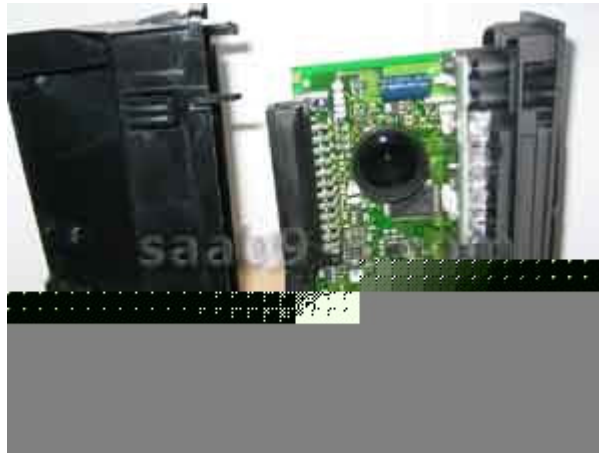
The housing should pull cleanly off easily, if its tough, check all press tabs are released!

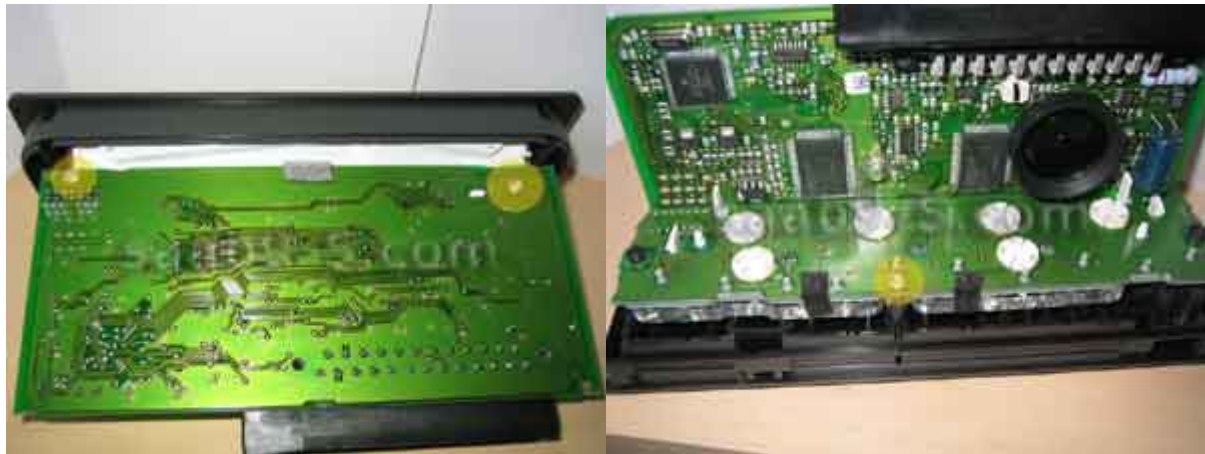
There are now another 3 screws to remove, once removed the actual LCD panel and board can be separated from fascia

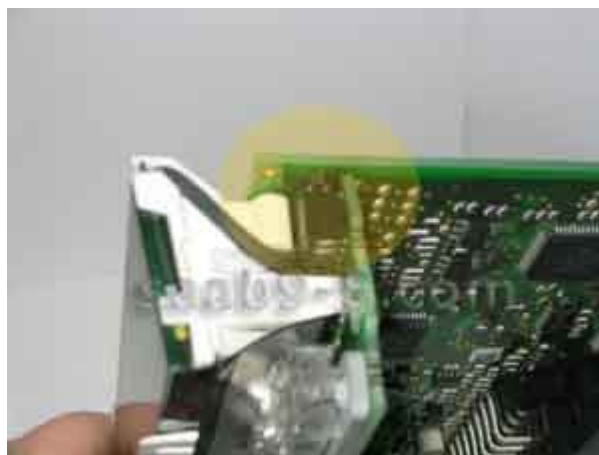
Now you will need to very carefully separate the LCD panel from the main PCB, there is a plug on one corner, remove carefully so not to suddenly pull apart and damage ribbon cable!

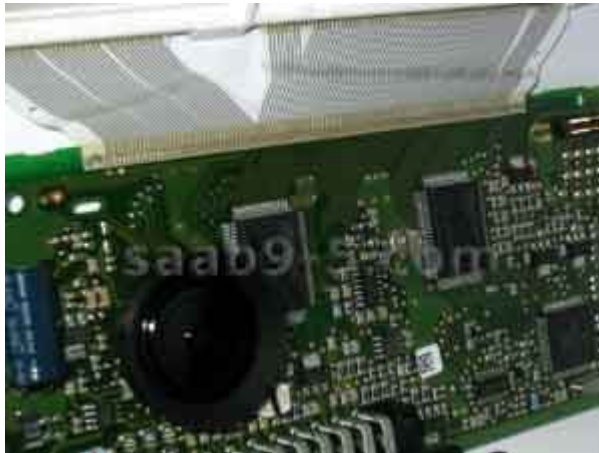
Now carefully lay the 2 parts apart on some anti static foam/mat, this will reveal the ribbon cable, the most common cause of SID failures

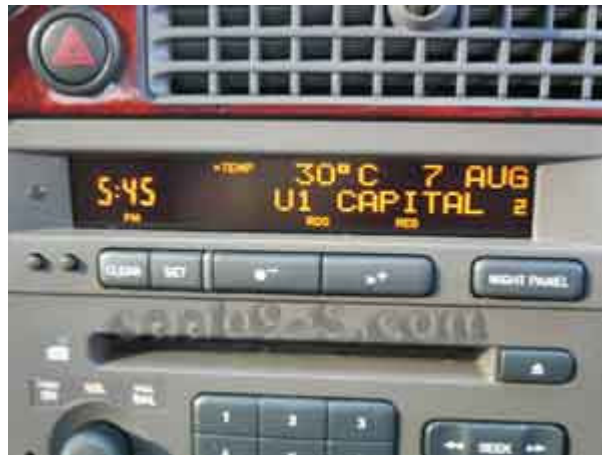
And hopefully the end result will look something like this!
