SERVICE INSTRUCTION

Number: 381-1933

SID message "TIME FOR SERVICE"

All Saab 9-5

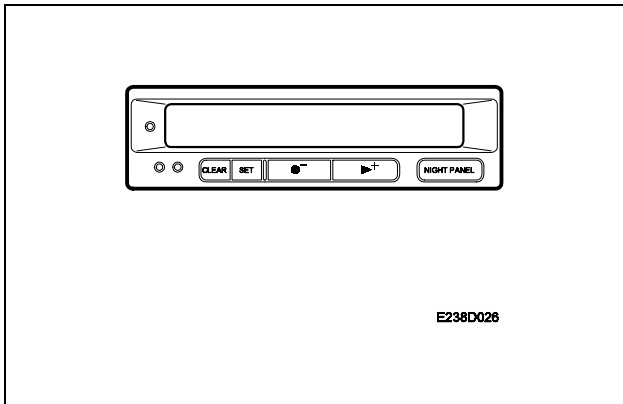
The new software in the SID requires a different procedure to cancel the "TIME FOR SERVICE" message with the CLEAR button on the SID.

To reset the "TIME FOR SERVICE" message on the SID (without using Tech 2), the following procedure must be followed:

- 1 Press the CLEAR button once.
- 2 Press the CLEAR button a second time and hold it pressed in for at least 8 seconds.
The SID will give two acoustic signals one shortly after the other. On the second signal the message "SERVICE" will start to flash.
- 3 Start the engine to make sure that the message has been cancelled.
